## IOActive Security Advisory

Title	Unauthenticated Stack-based Buffer Overflow in Session Cookie
Severity	9.6 - CVSS:3.0/AV:A/AC:L/PR:N/UI:N/S:C/C:H/I:H/A:H
Discovered by	Alexander Bolshev Tao Sauvage
Advisory Date	October 24, 2019

- Antaira LMX-0800AG 8-Port Industrial Managed Ethernet Switch (<http://www.antaira.com/products/managed-10-100Mbps/LMX-0800>), firmware version 3.0

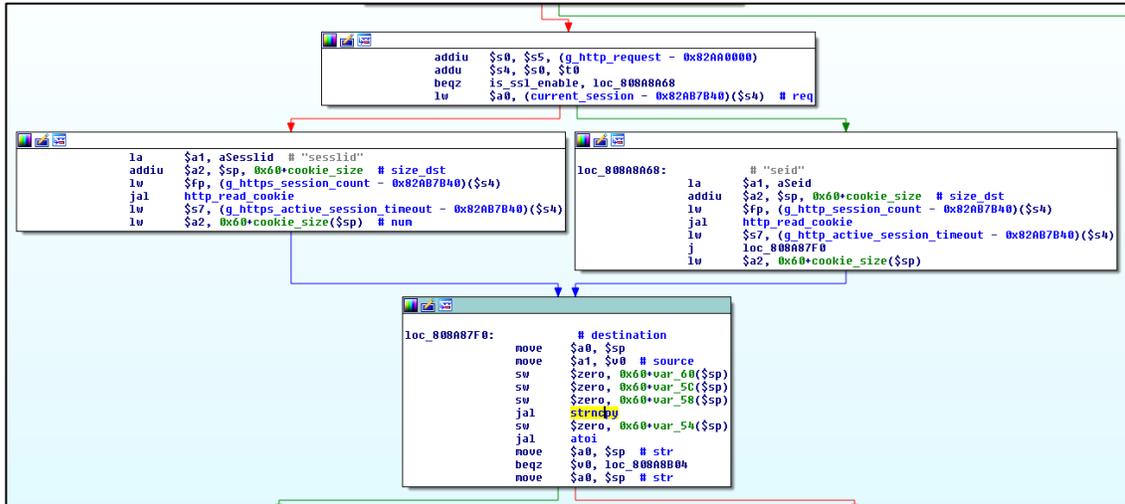
IOActive believes that the buffer overflow occurs at `0x808A8804`:

In the screenshot above:

- In the first box, the web module checks whether TLS is enabled. If it is enabled, the execution flow takes the left branch, otherwise, the right branch is taken.
- In the next two boxes, the module retrieves the cookie value of sesslid or seid from the request by calling http\_read\_cookie. The length of the cookie value is stored in cookie\_size.
- In the last box, the function strncpy is called with the destination (static buffer allocated on the stack), source (the cookie value), and num (the size of the cookie value) parameters.

In the vulnerable code above, the call to `strncpy` should instead use the length of the `destination` buffer for the third parameter, instead of the length of the `source` buffer.

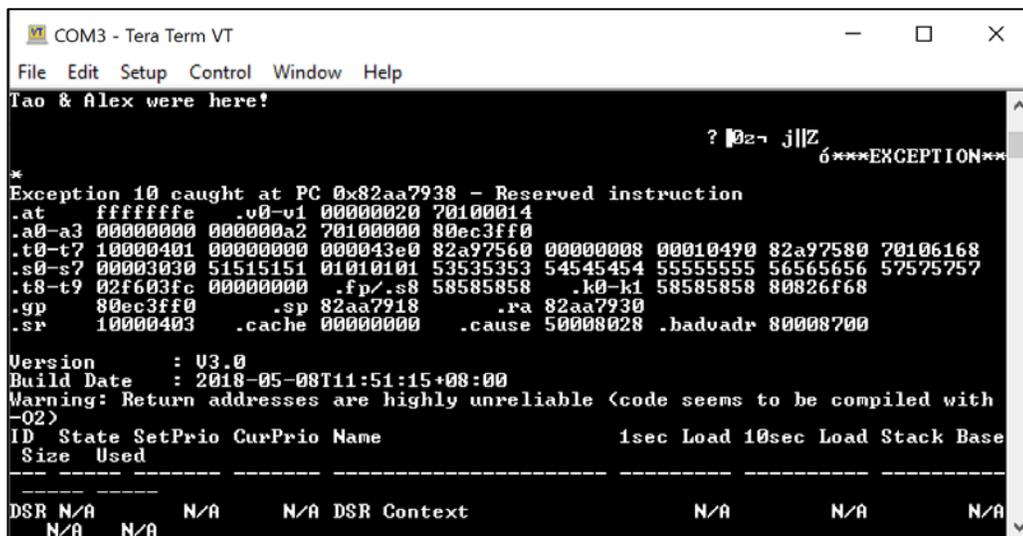
As a simple proof-of-concept, an exploit was developed that outputs a custom string to the serial console:

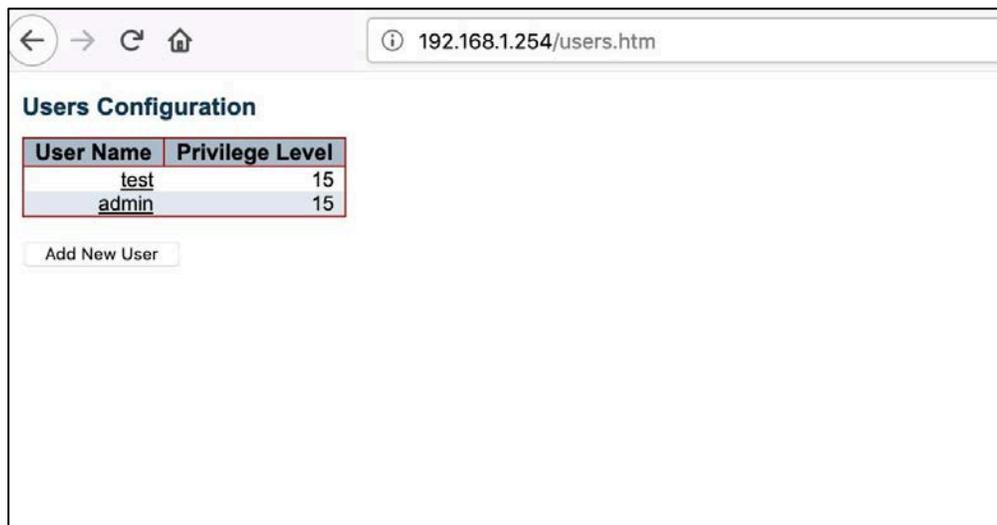
When an operator (authenticated on the switch's web interface) visits the malicious page, the new user is successfully created:

IOActive recommends switching from an only-persistent authentication method (cookie or HTTP authentication) to a transient authentication method, such as cookies plus a hidden field provided on every form. This type of authentication will help prevent attacks including CSRF and denial of service.

Another possible solution would be to include a secret, user-specific token, and/or user-controllable data (CAPTCHA, resubmitting a password) into each form, in addition to the authentication cookie.
